## Lead Free Tin Whiskering Study

### Grayhill DIP Switches

May 11, 2004  
Revision A

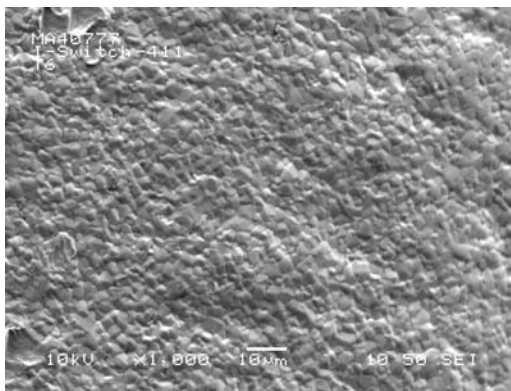
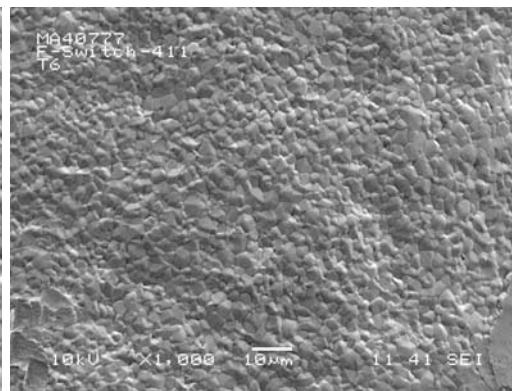
Switch #411 before thermal cycling      Switch #411 after thermal cycling

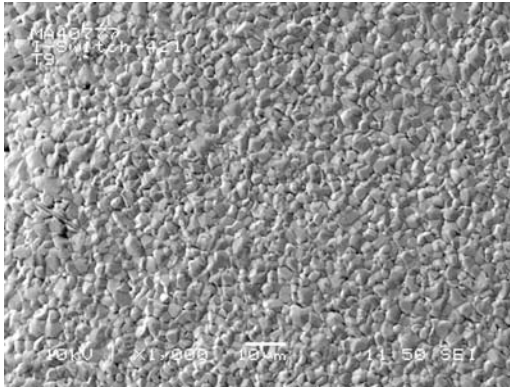
Switch #421 before wave solder and storage

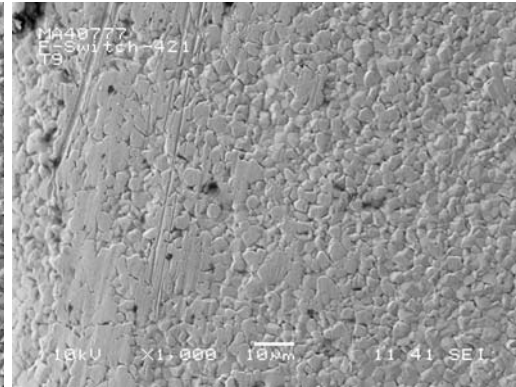
Switch #421 after wave solder and storage
