POLYTERM® FLEXIBLE SMD TERMINATION

CHRISTOPHER ENGLAND APPLICATIONS ENGINEER / HVS PRODUCTS

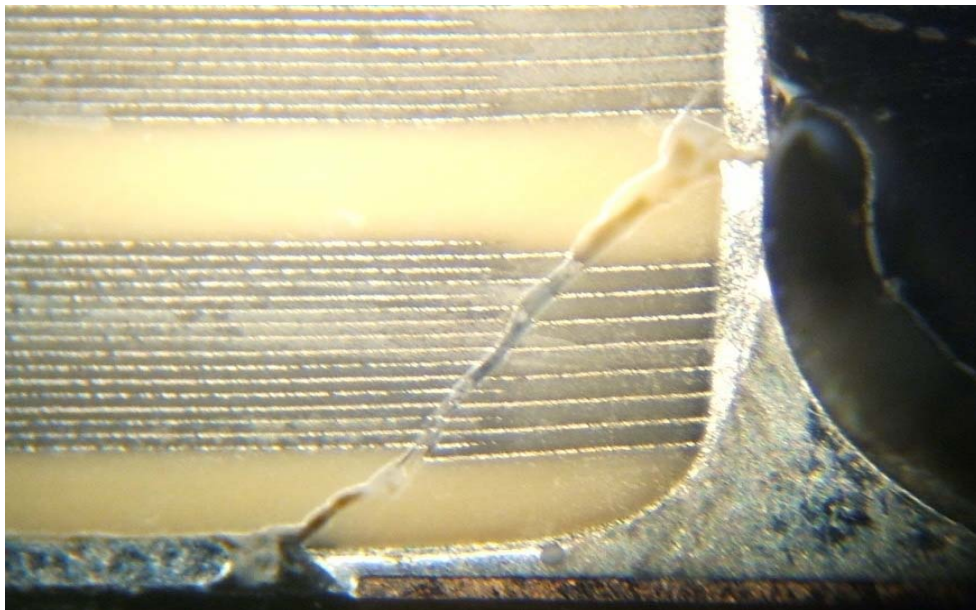
Cracked capacitors can manifest themselves as latent defects including increased leakage current, intermittent opens, shorts or no problem found when field returned assemblies are analyzed. In some cases these defects can lead to catastrophic failure depending on the application energy available. Cracks could be introduced at virtually any point in the surface mount assembly process from pick and place, soldering and reflow, handling after assembly, depanelization, board level testing or equipment assembly (see below example of standard termination after flexing). Board flexure and handling are the predominant source of capacitor cracking. Polyterm® Flexible SMD Termination was developed to provide a flexible bond capable of withstanding higher physical strain than standard terminations. Standard terminations are more susceptible to cracking during processing, which may not be discovered by visual means. Over time these cracks can propagate into opposing electrodes within the capacitor possibly causing the capacitor to fail short, and subsequent catastrophic failure. Polyterm®, in addition to proper board layout practices, provides added protection and greatly reduces the possibility of the capacitor failing due to these board stresses.

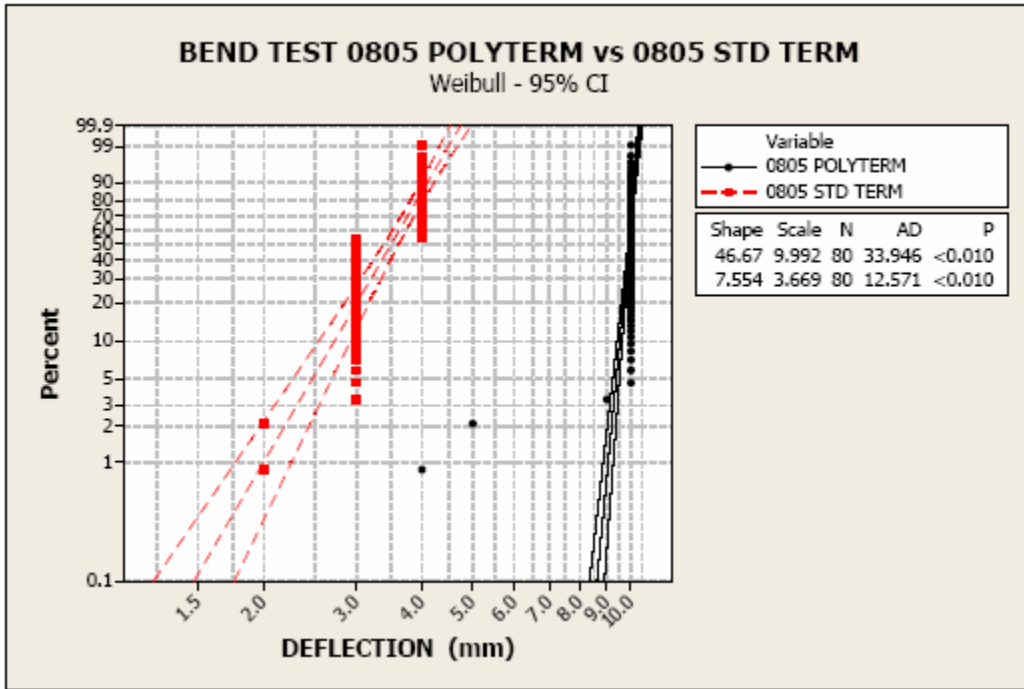
Figure 2

COMPARISON OF STANDARD TERMINATION vs POLYTERM®

Group 1) 80 samples and were subjected to gradual bending measured incrementally in 1 mm steps from 1mm to 10mm. A failure would be indicated by loss of capacitance >10% (JIS-C-6429). These samples were then removed from the board and the terminations were etched from the capacitor body. The ceramic body was then physically inspected for damage. Both Polyterm[®] and Standard terminations were subjected to this experiment. Each different part size is represented by the summary of test results (Figure 1) and a graph Showing cumulative failure of both Polymer and standard terminations (Figures 2-7)

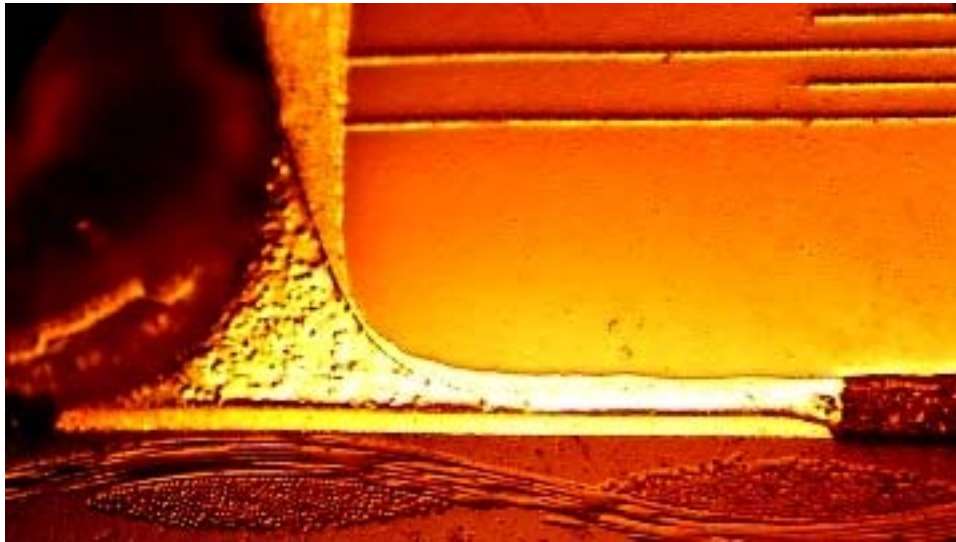
Figure 8 Undamaged Termination 1mm Deflection

Group 2) Samples were bent to varying degrees of deflection to provide photographic representation of how the polymer terminations perform and illustrate how failures manifest themselves. This test was performed using the S47 (2220) sample group (figures 8-12). One board for each mm of deflection was used.

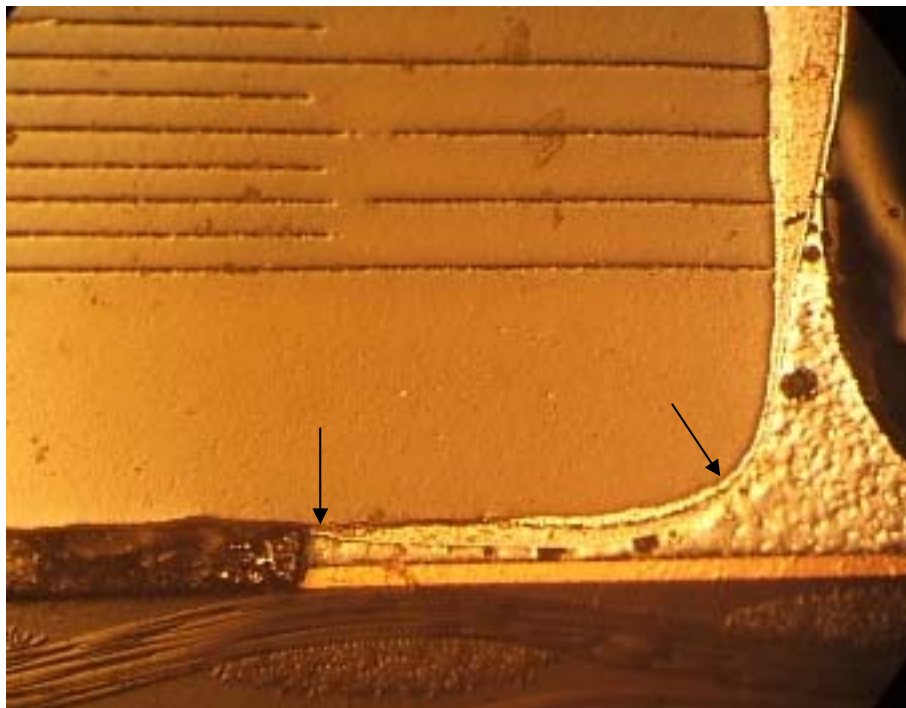
Figure 9 Partial Separation of Polymer 3mm deflection.

At 3mm only partial separation of the polymer was visible. The silver layer is clearly separating from the polymer with no ceramic damage visible.

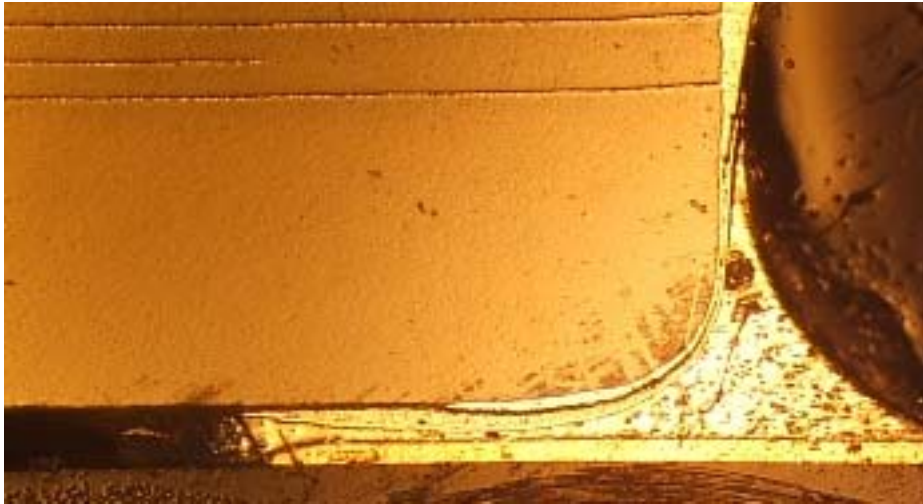
Figure 10 Partial Separation of Polymer 4mm

The photo in Figure 10 shows almost complete separation of the silver termination from the polymer layer. Although the polymer layer is partially separated the capacitor still operates normally. When returned to the original state all capacitors regardless of failure operated within specification.

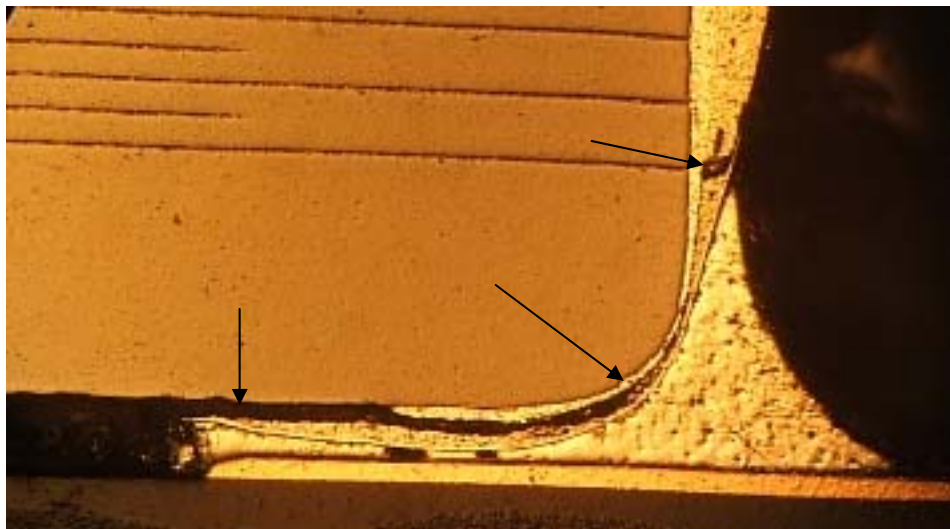
Figure 11 Complete Separation of Polymer Layer 5mm

Complete separation of the polymer layer may cause open capacitor, but ceramic failure was not observed. This will protect against the capacitor failing short causing catastrophic failure.

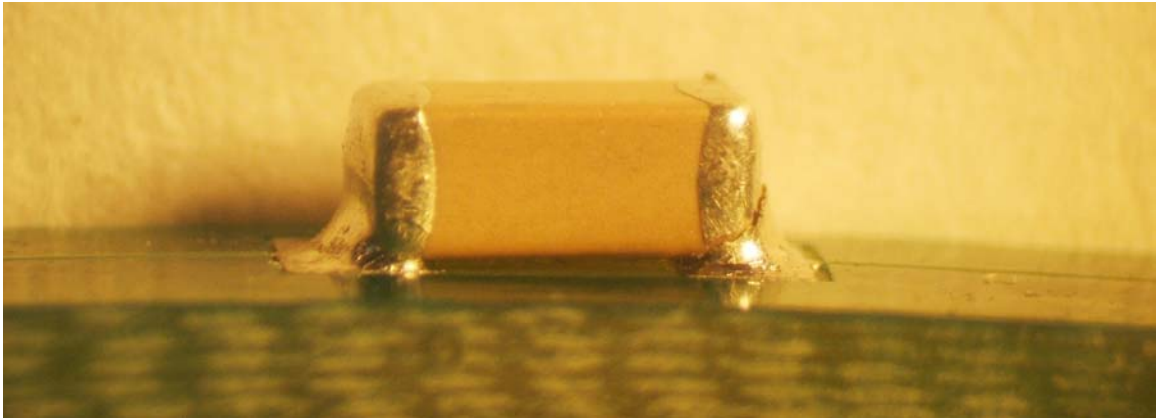
Figure 12 Capacitor with Complete Separation of Polyterm[®] Termination During Flex testing.

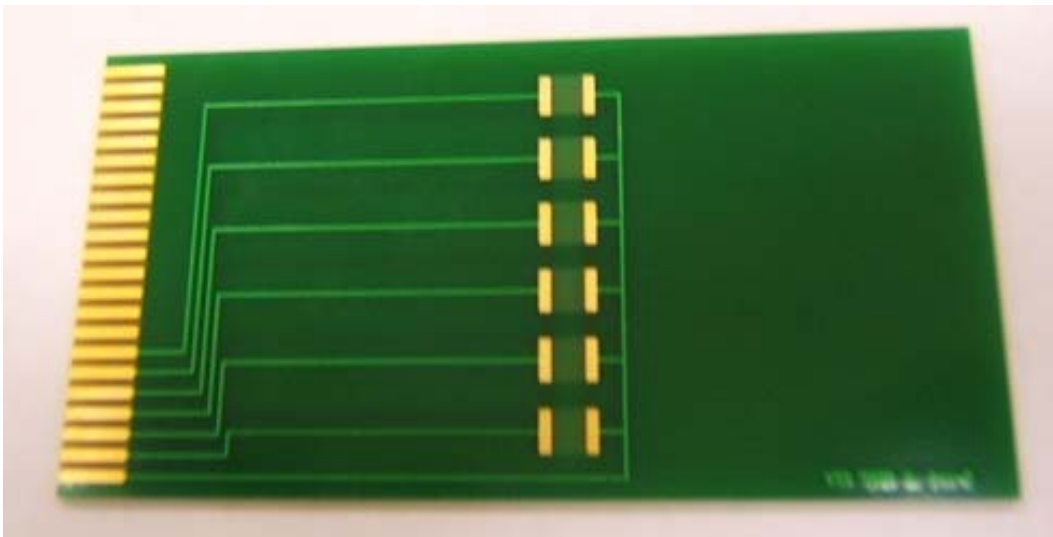
Figure 13 Flex Test Board

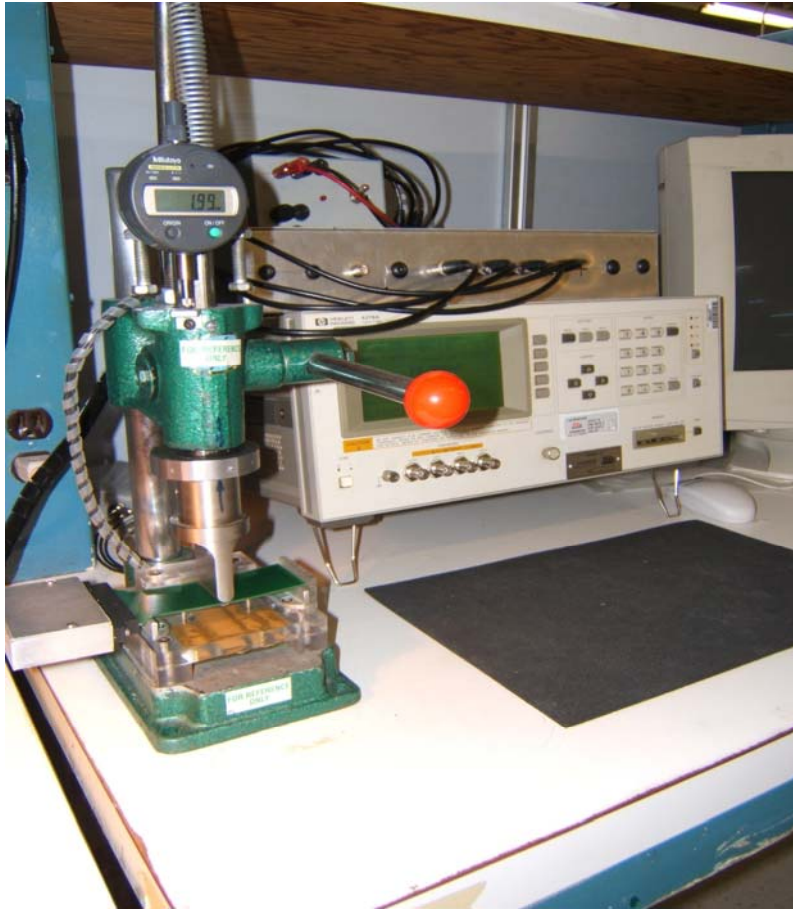
Figure 14 Flex Test Fixture W/CPU for Data Storage

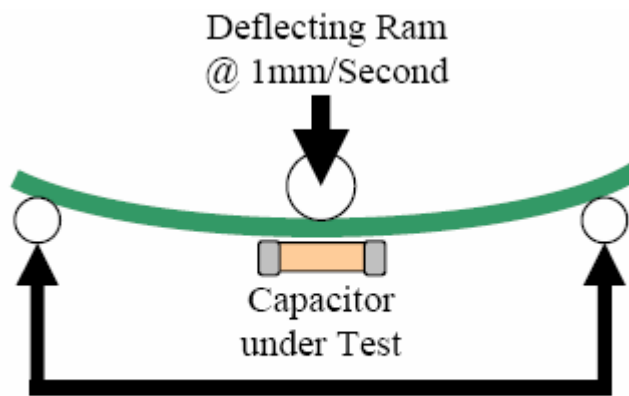
Support w/90mm Span
Figure 15 illustration of bend test
