FAILURE MODES OF TANTALUM CAPACITORS MADE BY DIFFERENT TECHNOLOGIES

P. Vasina, T. Zednicek, J. Sikula*, J. Pavelka*
AVX Czech Republic s.r.o., Dvorakova 328, 56301 Lanskrout, Czech Republic

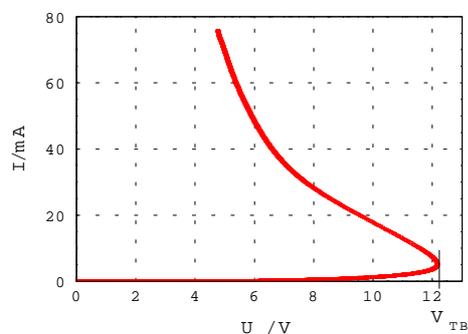
Experimental results on tantalum capacitors show that negative differential resistance has an “S” shaped V-A curve (Fig.1.).

Fig.1. V-A characteristic in reverse mode of MnO₂ tantalum capacitor system.

Negative differential resistance, with a specific series resistance, was observed for several types of capacitors and manufacturers (see example in Fig.1.).

In this case, we believe that the instability of current controlled negative differential resistance is created by either a random noise fluctuation or non-uniformity in doping, and is related to thermal excitation of the carriers. Such an effect should be temperature dependent, and local heating will take place within the device. This will, in turn, lead to a conductance change. This kind of instability is related to the electrical noise. Additional noise measurements will give us more information about the origin of this phenomenon.

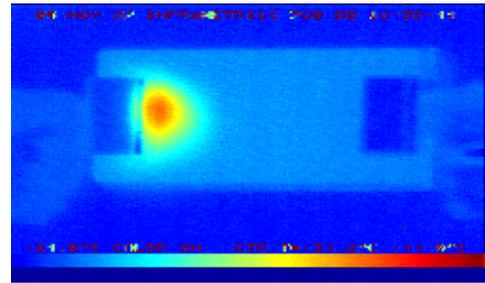
Fig. 2. Self-healing process under IR camera

A breakdown test was performed in order to evaluate self-healing processes of both the MnO₂ and conductive polymer technologies. Current step-up sweep was used to increase load voltage by small increments until electrical breakdown occurred. The ability of the capacitor to recover / self-heal the breakdown failure spot was monitored by voltage drop and IR camera check.

Controlled thermal breakdown in the normal operating mode gives rise to self-healing of weak spots and a reduction in the generation of local defect sites.

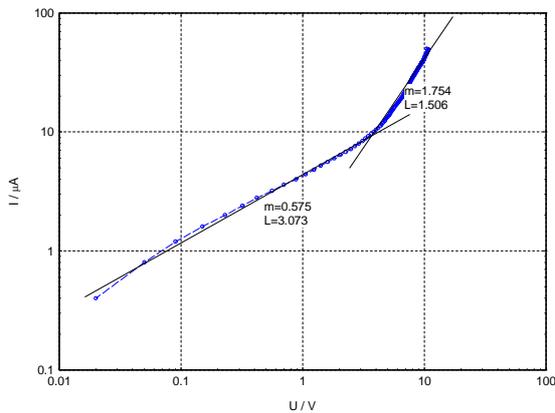
The first section of the V-A characteristic curve (see Fig. 3.) can be described as a square

law dependency that is related to the injection of current into the insulating layer with trap-fillet-limit. The second section is a quadratic dependence due to space charge limited current injection with uniform trap distribution. The transition point between these two processes depends on Fermi level energy with respect to trap activation energy. The Poole-Frenkel mechanism is overlapped with current injection into insulator limited by space charge. Electric field intensity is not homogeneous and is extremely high near the injection electrode; thus, it is critical for cathode material requirements.

Fig. 3. Tantalum capacitor with conductive polymer in normal mode.

The V-A characteristic of the conductive polymer capacitor, on the other hand, has a first section, the low intensity region, that is described as a square law dependency. It is related to the current injection into the insulating layer with trap-fillet-limit. This is consequently followed by a section of quadratic dependence due to space charge limited current injection with uniform trap distribution.

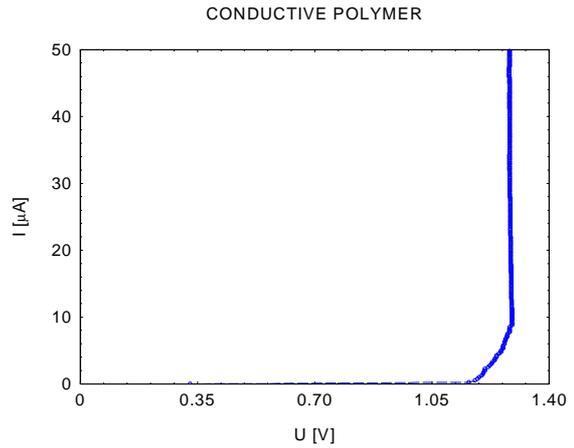
Negative differential resistance, with a specific series resistance, was not observed for conductive polymer technologies (see example in Fig.4.). This is due to the feedback in the temperature - conduction - Joule heating – increased temperature cycle in high current density channels via dielectric.

Fig. 4. Tantalum capacitor with conductive polymer in reverse mode.

Because the mechanism of transition in the reverse mode is significantly proportional to the dielectric performance, the same result should be attained. Another difference can be found in the lower level of breakdown voltage because of the different function of cathode material.

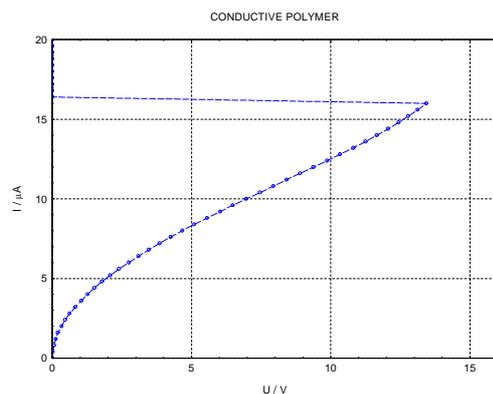
There have been significant differences reported between individual CP manufacturer technologies. Capacitors made by the first technology have shown breakdowns without record of any self-healing processes and short circuit of the capacitor after dielectric breakdown (see Fig. 5.). No single breakdown voltage has been found in the case of the second technology. During the test, the current was continuously increased up to thermal breakdown with no self-healing observed.

Fig. 5. Dielectric breakdown results in short for conductive polymer made in the first technology.

MnO₂ parts were found to be more capable of self-healing during the electrical breakdown experiment than either of the conductive polymer technologies tested. No efficient self-healing processes were found during the test to confirm the theories on conductive polymer materials. Some additional work on conductive polymer materials may be required in order to understand their physical properties and potentials for future applications.
